**INFLUENCE OF HULL CONFIGURATION AND VESSEL  
PROPULSION SYSTEMS ON SEA TURTLE SHELL  
INJURIES**

A Thesis  
Presented to  
The Academic Faculty

In Partial Fulfillment  
of the Requirements for the Degree  
Doctor of Philosophy in the  
School of Civil and Environmental Engineering

Georgia Institute of Technology  
August 2012

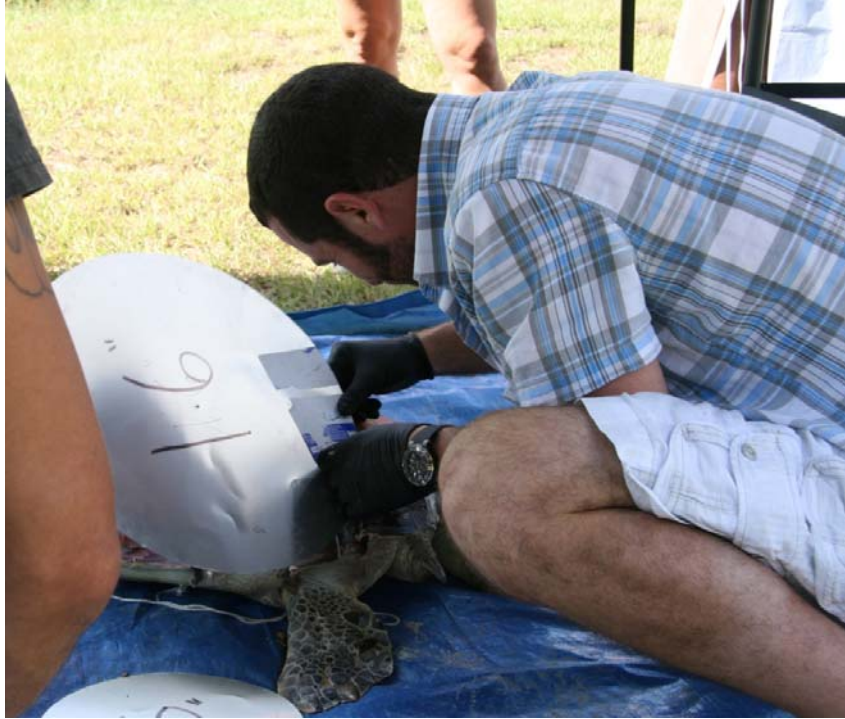
Figure 4.15. Measurement of propeller diameter from wound depth

After recovery of the turtle, photographs and measurements of the damage pattern, including depth and spacing of wounds, were taken. Measurements were made with a set of calipers, as shown in Figure 4.14. Metal discs of varying sizes were placed in the propeller wounds to estimate the diameter of the propeller size on the vessel, as shown in Figure 4.15.

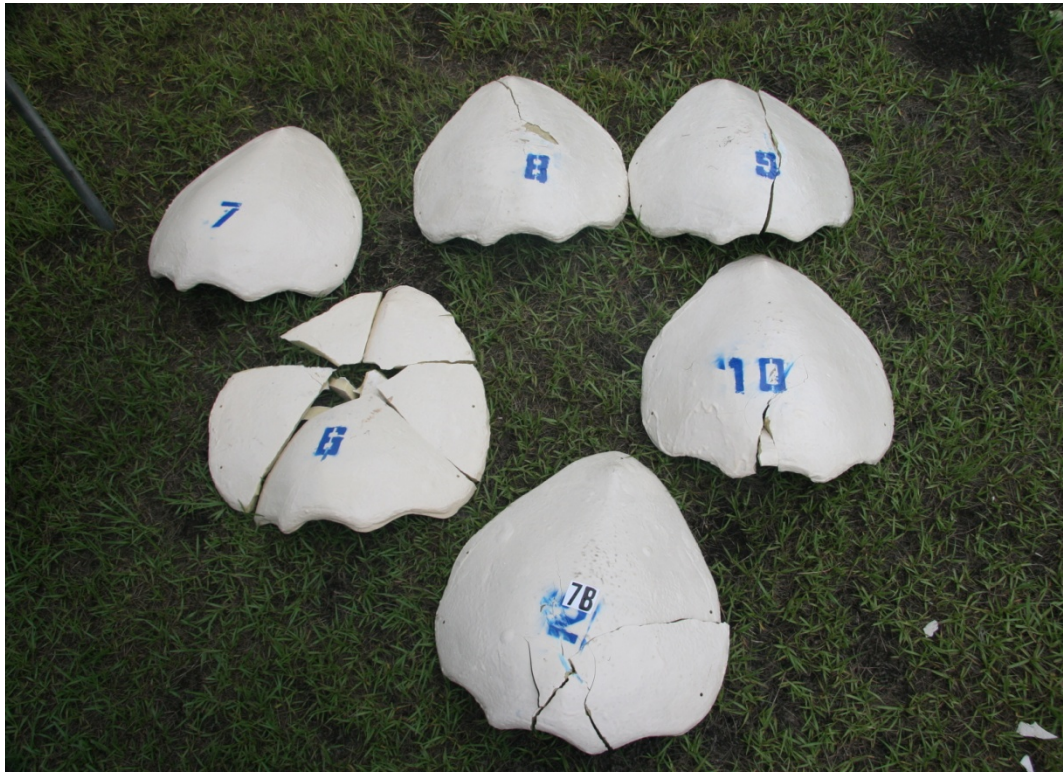
Figure 4.17. Results of test series at surface, Vessel 1, Round 1

A total of eleven tests were performed using Vessel 1 in the first round of testing. None of the turtles at 48 cm deep was struck by the vessel. All five tests were performed with the same shell, Shell 1. Of the six tests at the surface, five shells experienced hull impact and broke. The one shell that did not break, Shell 7, experienced an indirect hit from the vessel. This was noted by the boat operator and confirmed by the accelerometer data, which showed a much lower peak acceleration value, 6.5 g, compared to the other tests. Therefore, a sixth shell was tested, Shell 7B, which broke upon impact. The test results are summarized in Tables 4.4 and 4.5. A photograph of the five damaged shells is shown in Figure 4.17.

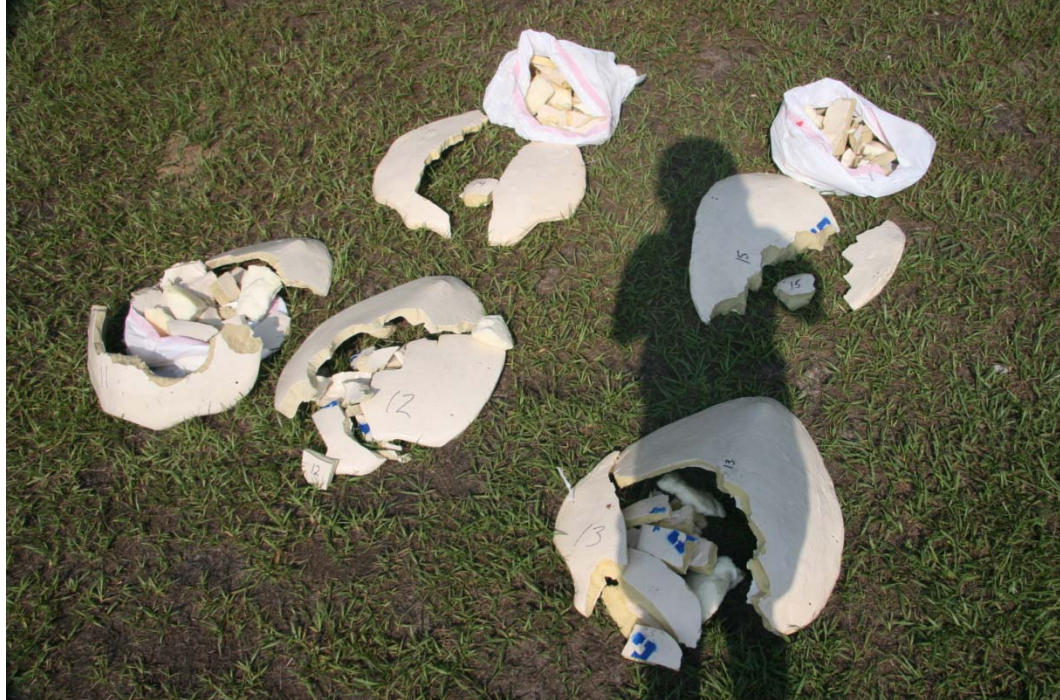
Figure 4.18. Results of test series at 48 cm, Vessel 2, Round 1

A total of 15 tests were performed using the 4-bladed propeller-driven vessel, five at each depth. The shells at propeller depth (71 cm) did not experience any vessel impact. Of the other ten test shells, nine were considered to have experienced fatal wounds, with one experiencing a non-fatal hull impact. The tests conducted at the surface were not outfitted with accelerometers to avoid damage to the sensors. The tests results are summarized in Tables 4.6 and 4.7. Photographs for each test series are shown in Figures 4.18 and 4.19.

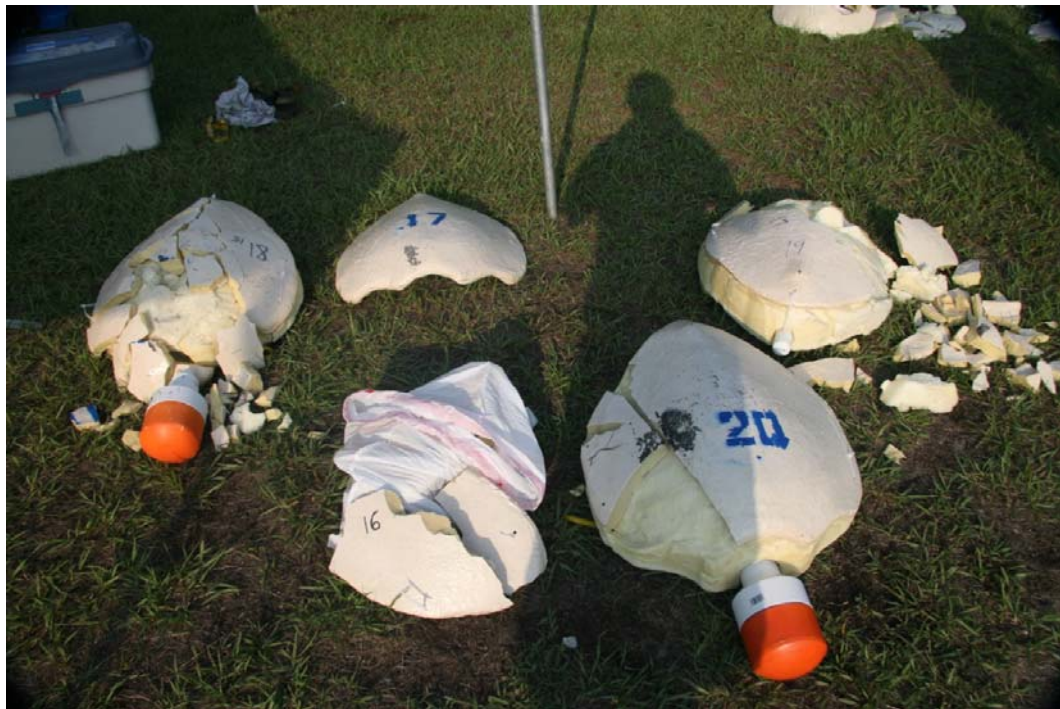
Figure 4.19. Results of test series at surface, Vessel 2, Round 1

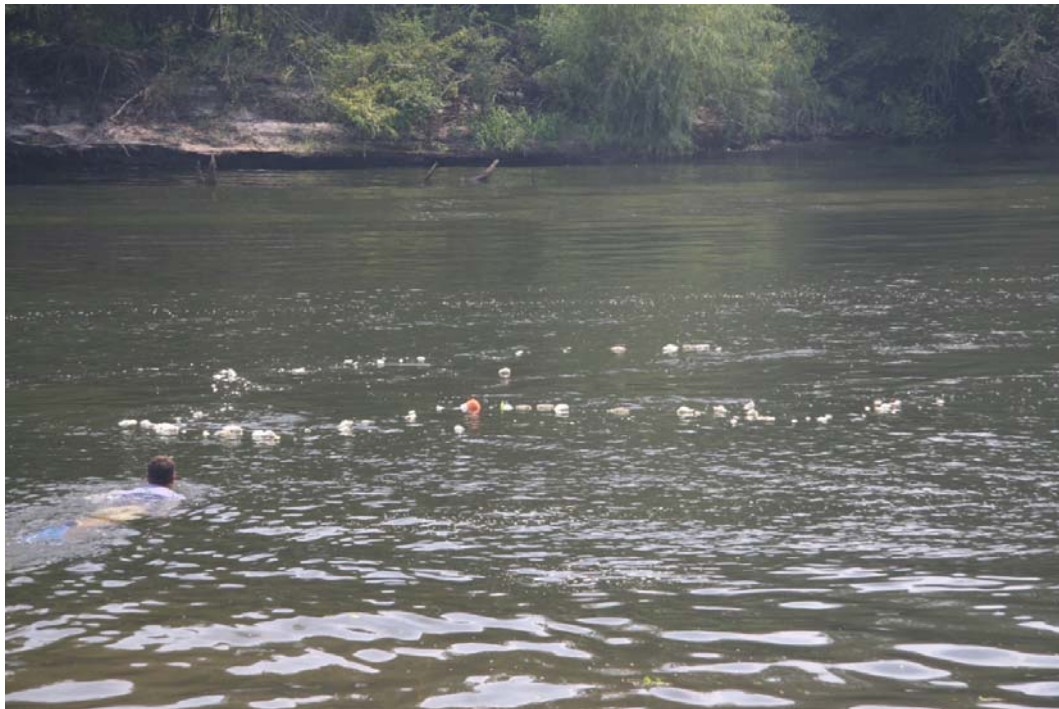
Figure 4.20. Debris in the water after impact of Vessel 2, Round 1

Modifications to the test specimens were deemed necessary after comparison of the failure methods and patterns exhibited by the artificial carapaces in Round 1 to wounds sustained by real turtles. Vessel 1 (jet drive) caused large, continuous cracks, which were unlike reported injuries. Vessel 2 (propeller drive) caused the turtle carapace to be completely destroyed, resulting in large amounts of debris in the water, as shown in Figure 4.20. Modifications to the attachment system between carapace and body were made to increase the energy absorption capabilities and reduce the amount of debris. These modifications are outlined in Section 4.3.1.1 .

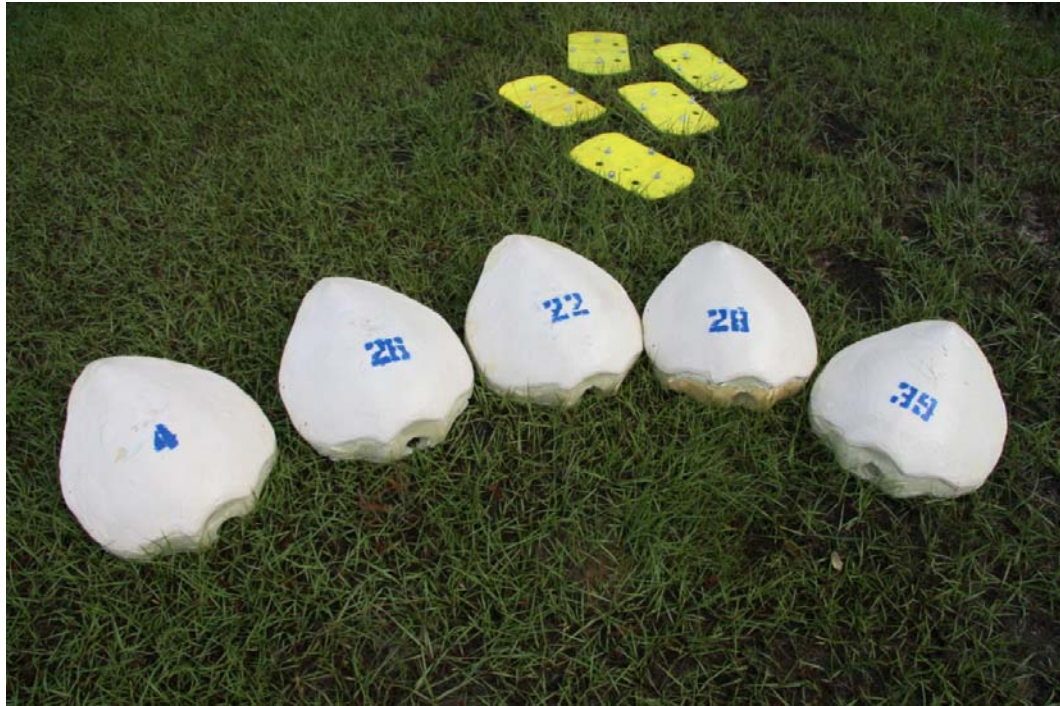
Figure 4.21. Results of test series at surface, Vessel 1, Round 2

Five shells were tested at the surface with the jet boat. None of the shells experienced damage which would be classified as a catastrophic injury. Small dents and cracks were noted at the location of impact in some cases, but the cracks did not propagate as they did in Round 1. The accelerometer readings indicate the shells experienced impact forces that were similar to the shells from Round 1. The drastic reduction in cracking illustrates the effect of the body revision and is a more realistic response. The results are summarized in Tables 4.8 and 4.9, and a photograph of the five shells is shown in Figure 4.21.

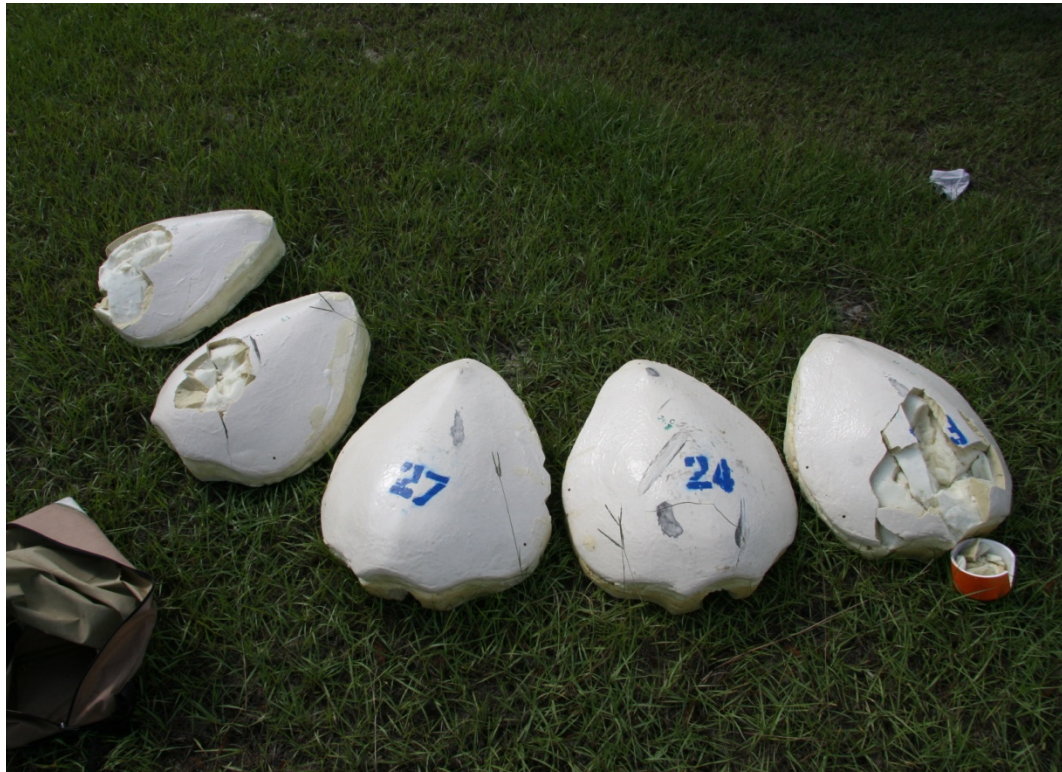
Figure 4.22. Results of test series at surface, Vessel 2, Round 2

Ten tests were conducted using Vessel 2: eight at surface depth and two at 48 cm. Two carapaces, Shell 23 and Shell 24, were used for multiple trials at the surface. The first vessel strike did not cause any damage from hull impact, so the trials continued until catastrophic injury was caused. These repeated tests are given as 23B, 24B, and 24C in the tables. The two trials at 48 cm were conducted using undamaged shells from the tests using Vessel 1, Shells 4 and 26. These are noted as Shells 4P and 26P and were not instrumented with accelerometers. The test results are summarized in Tables 4.10 and

4.11. A photograph of the five shells used at surface depth is shown in Figure 4.22, and Shells 4P and 26P are shown in Figures 4.23 and 4.24.

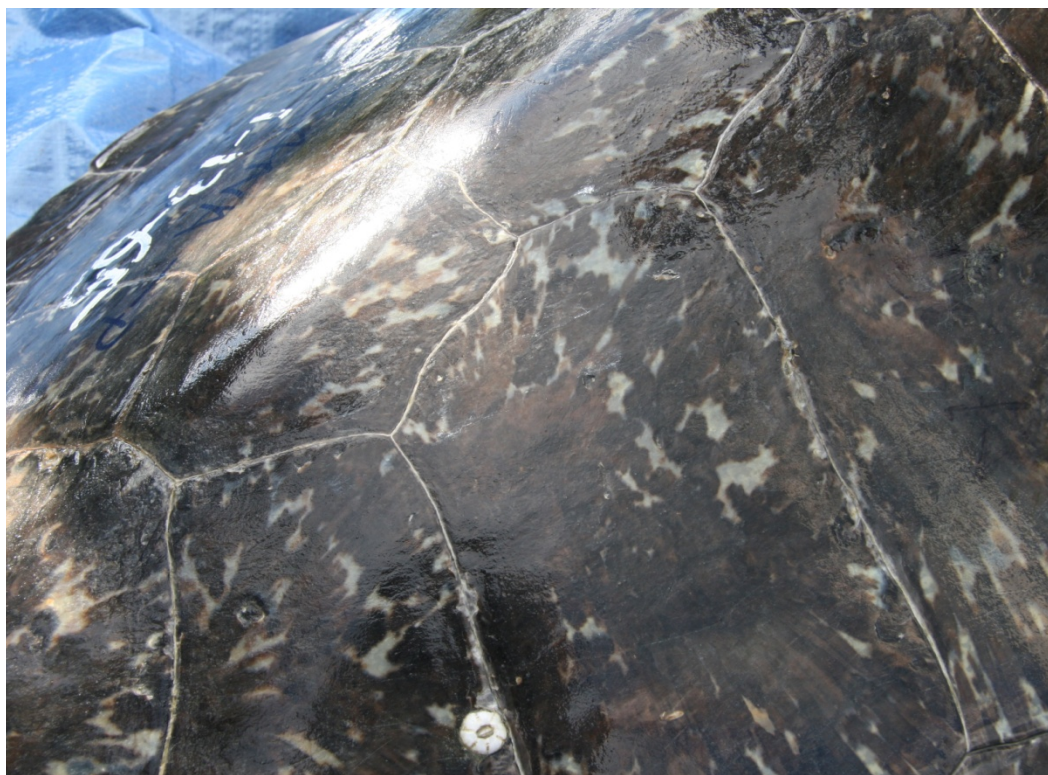
Figure 4.25. Abrasion on turtle R3 from hull impact of Vessel 1

Three tests were performed at surface depth with Vessel 1. None of the turtles sustained serious damage from the hull impact, with only small abrasions and cuts evident. The artificial carapaces from Round 2 and the real turtles showed similar types and degrees of injury when subjected to hull impact from the jet propulsion vessel. The results are summarized in Table 4.13 with a photograph of R3 in Figure 4.25.

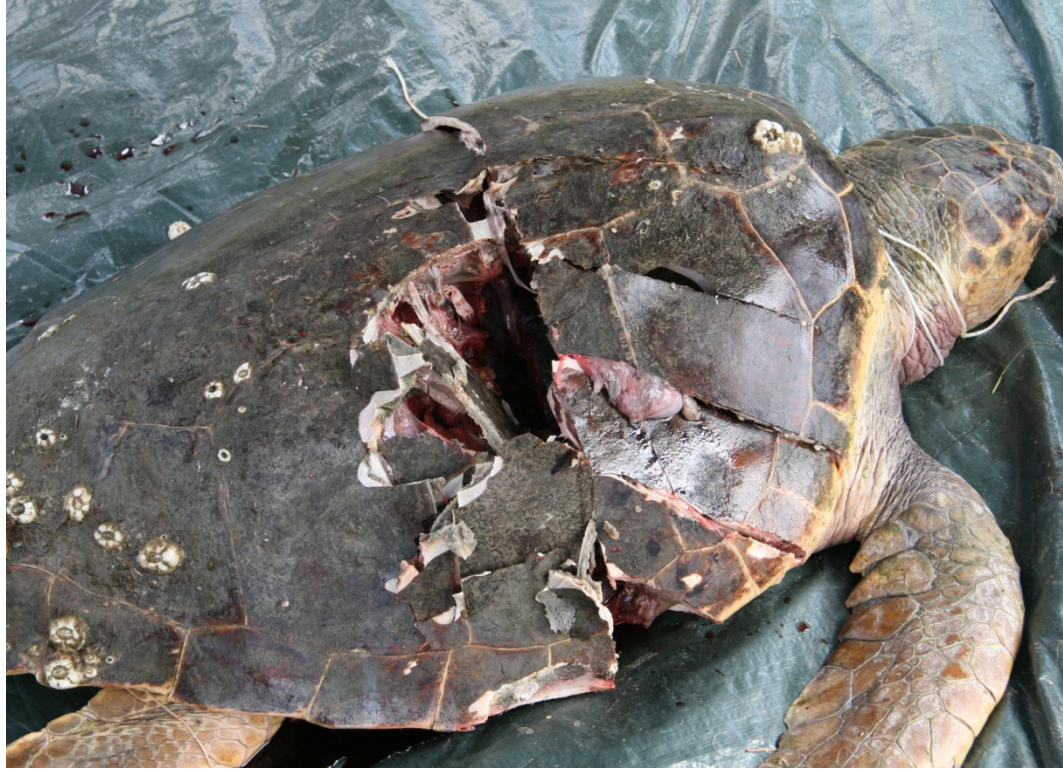
Figure 4.26. Skeg and propeller wounds in turtle R1

The turtles experienced severe damage from both the skeg and propeller. All ten

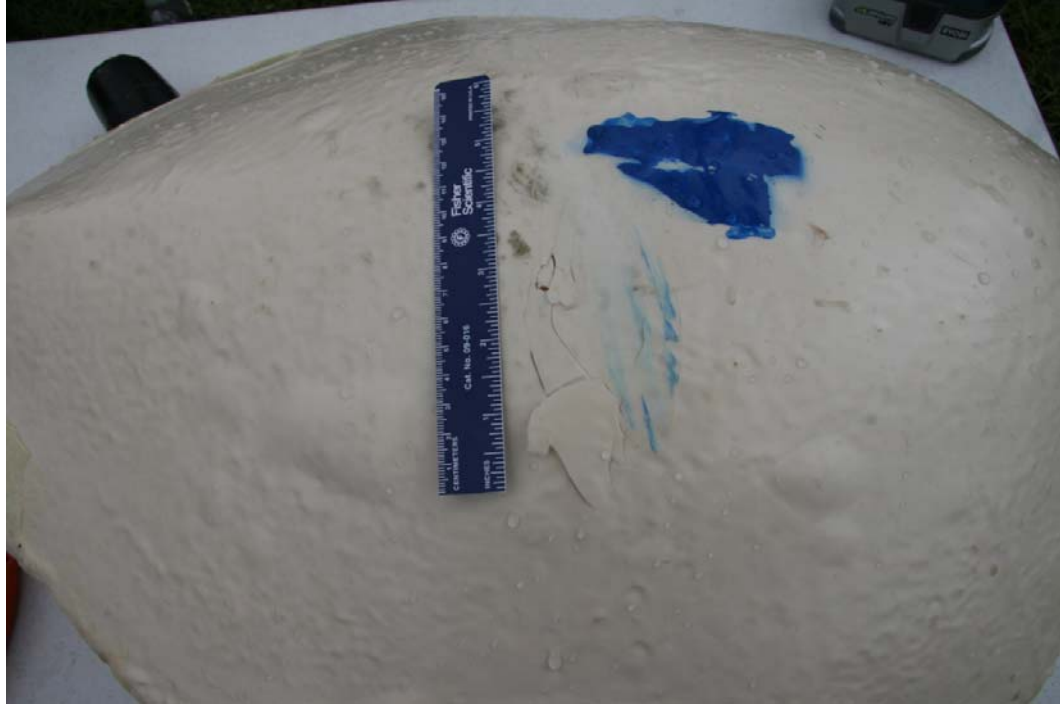
Figure 5.11. Surface cracks on Shell 4, Vessel 1, Round 2

The faces suffered a significant number of failed elements at 11.2 kN and above. At the baseline force of 8.75 kN, a small number (four) of the shell elements showed stress levels beyond the ultimate strength. This is quite similar to the results of many field tests, which showed small cracks at the contact area from the hull impact of the jet drive vessel, as shown in Figure 5.11.

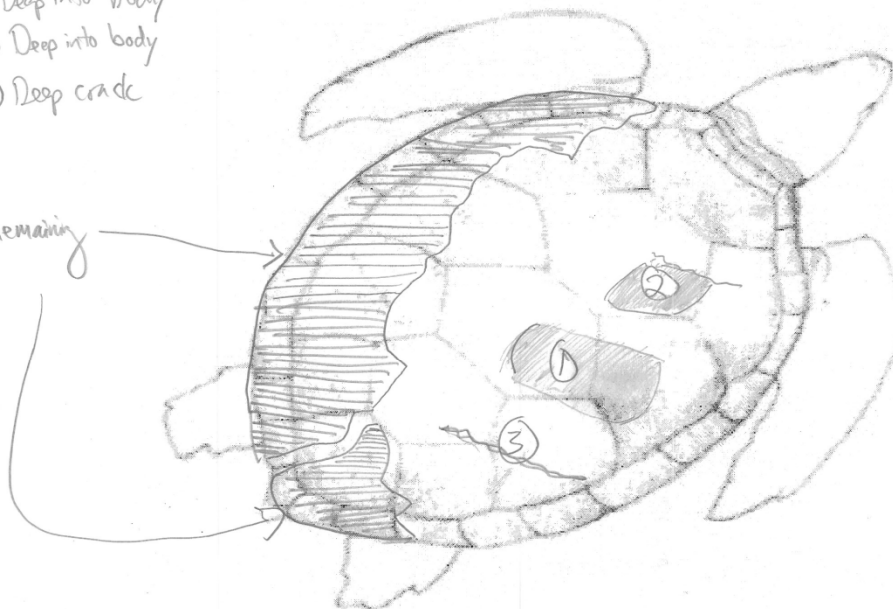
Figure B.23. Data sheet for Shell 18

Sketch of damage:

- ① Deep into body
- ② Deep into body
- ③ Deep crack
